THE 1597 TSUNAMI IN THE RIVER VOLGA***Irina I. Didenkulova¹⁾ and Efim N. Pelinovsky²⁾**¹⁾ Nizhny Novgorod State University, Nizhny Novgorod, Russia,²⁾ Institute of Applied Physics RAS, Nizhny Novgorod, RussiaE-mail: dii@appl.sci-nnov.ru**ANNOTATION**

The fortunate find of a description of the 1597 tsunami in the River Volga determined that the tsunami was due to a collapse a cliff near the river, which caused a landslide. Data collected at the inspection of the site mentioned show evidence of a strong landslide probability to induce tsunami in the river. Evaluation of the event parameters has been made.

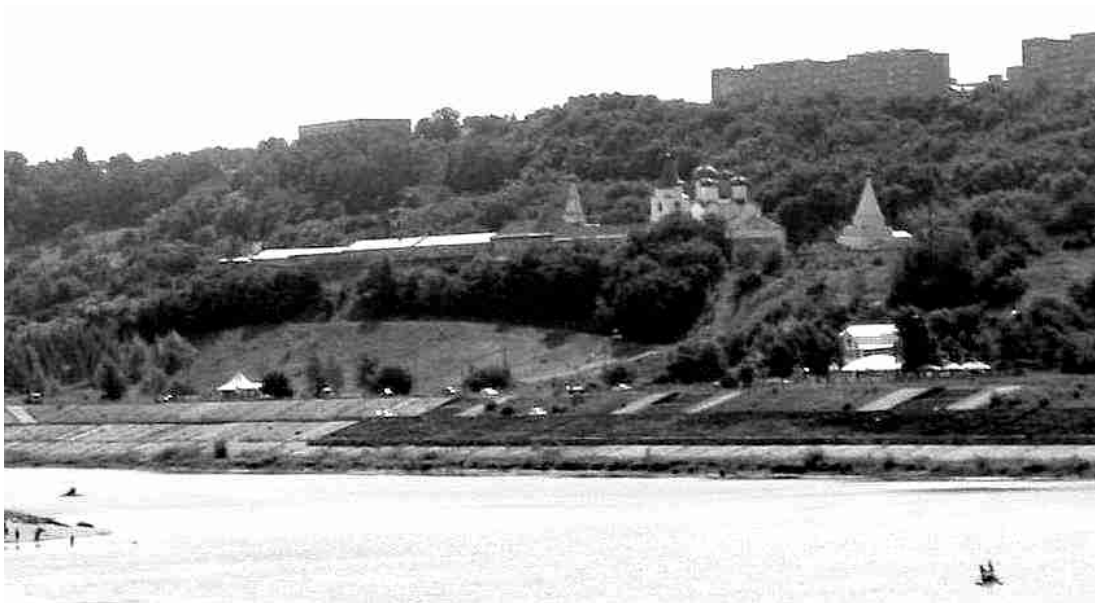
Figure 5.

They rebuilt the monastery after the catastrophe two kilometers closer to the town center (Fig. 5). For a long time it had been deserted, but in recent years it began to be actively reconstructed. Now it is open and performs religious services.

Fig. 5 gives also a general idea about the Volga's cliffs inside the city boundary. They are quite steep and conducive to slide formation. The same chronicle mentions, "a big slide occurred over the so-called salt bams" in 1867. Even now there is a high risk of a slide. The Committee for Environmental Protection and Nature Management of the Nizhegorodsky Region informed that in the year 2000 alone, 3 new slides were formed and 33 old slides were activated in Nizhny Novgorod along the cliffs of the Oka and the Volga rivers [State of..., 2001]. Maximum sliding activity was observed in April 2000. The largest newly formed slide inside the city boundaries was the slide in the Pochainsky ravine. Its length was 45 m, the width 30 m, and the sheared depth 5 m. Main causes of slide formation are precipitation, high level of subsoil water, and shore erosion.
